# *Final Report*

## **Deflecting the Wave: Using Coastal Vegetation to Mitigate Tsunami and Storm Surge**

Tropical Landscape and Human Interaction Lab  
Department of Tropical Plant and Soil Sciences  
College of Tropical Agriculture and Human Resources  
University of Hawai‘i at Mānoa

**June 2015**

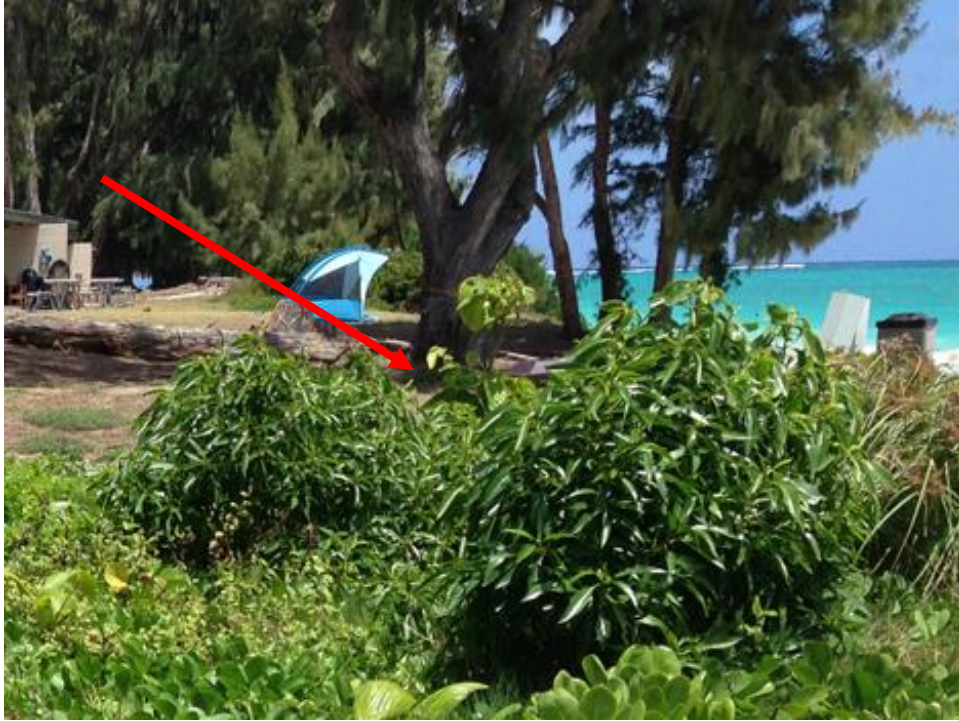
Figure 201. Kou, three months after planting.

Kou is a popular native tree, widely used for landscaping, especially as a street tree. However, this trial demonstrated that kou is salt sensitive to a degree that the planted trees would not grow taller than the shrubs (naupaka, naio and beach heliotrope) growing in front of them (figures 200 to 202). There were signs of salt damage, such as burnt leaves and apical meristems, and lateral branching. However, most of the specimens survived. Maybe this species will require more time to grow above the surrounding vegetation, and is more suitable as a back dune tree.

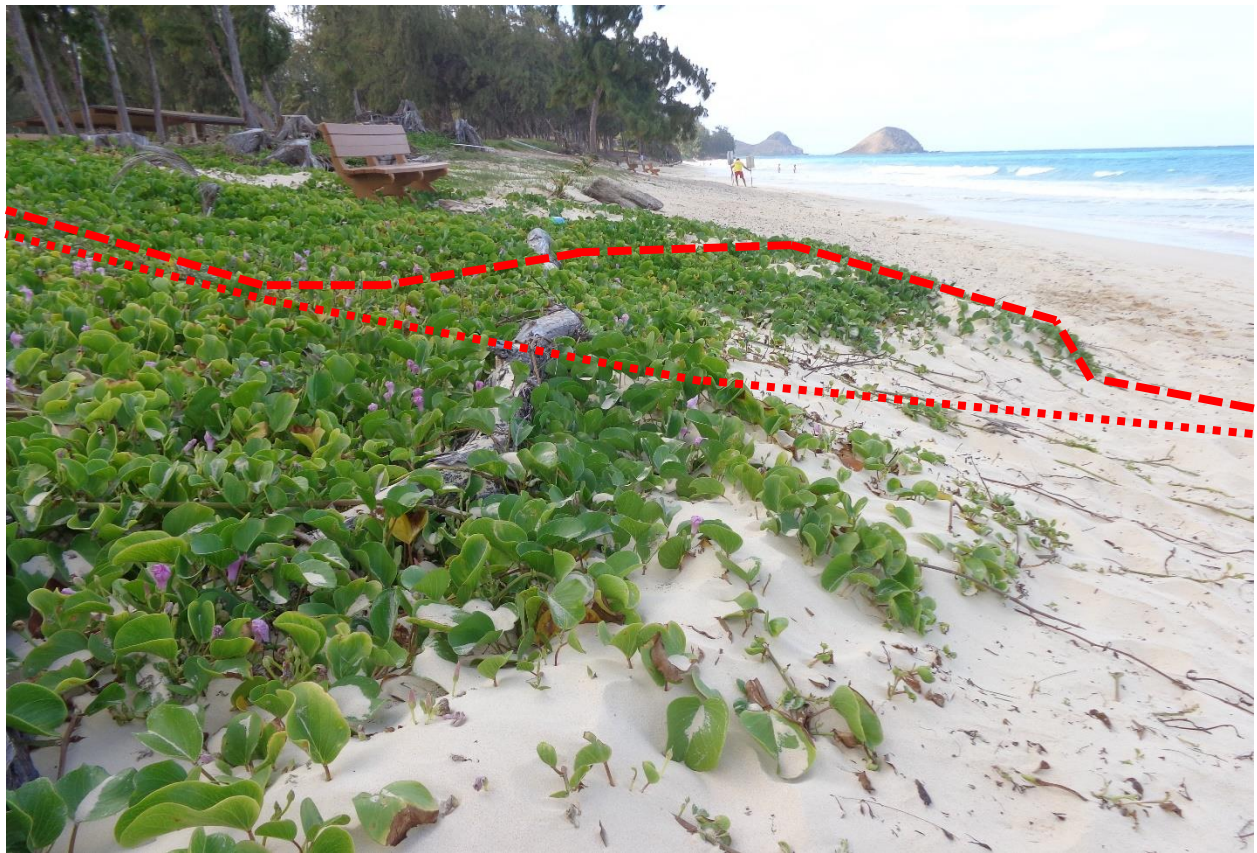
Figure 204. *Ipomea pes-caprae* subsp. *brasiliensis* growing in the foredune. The dashed lines represent the buildup sand (accretion) after planting. The dotted line represent the original sand profile, before planting.

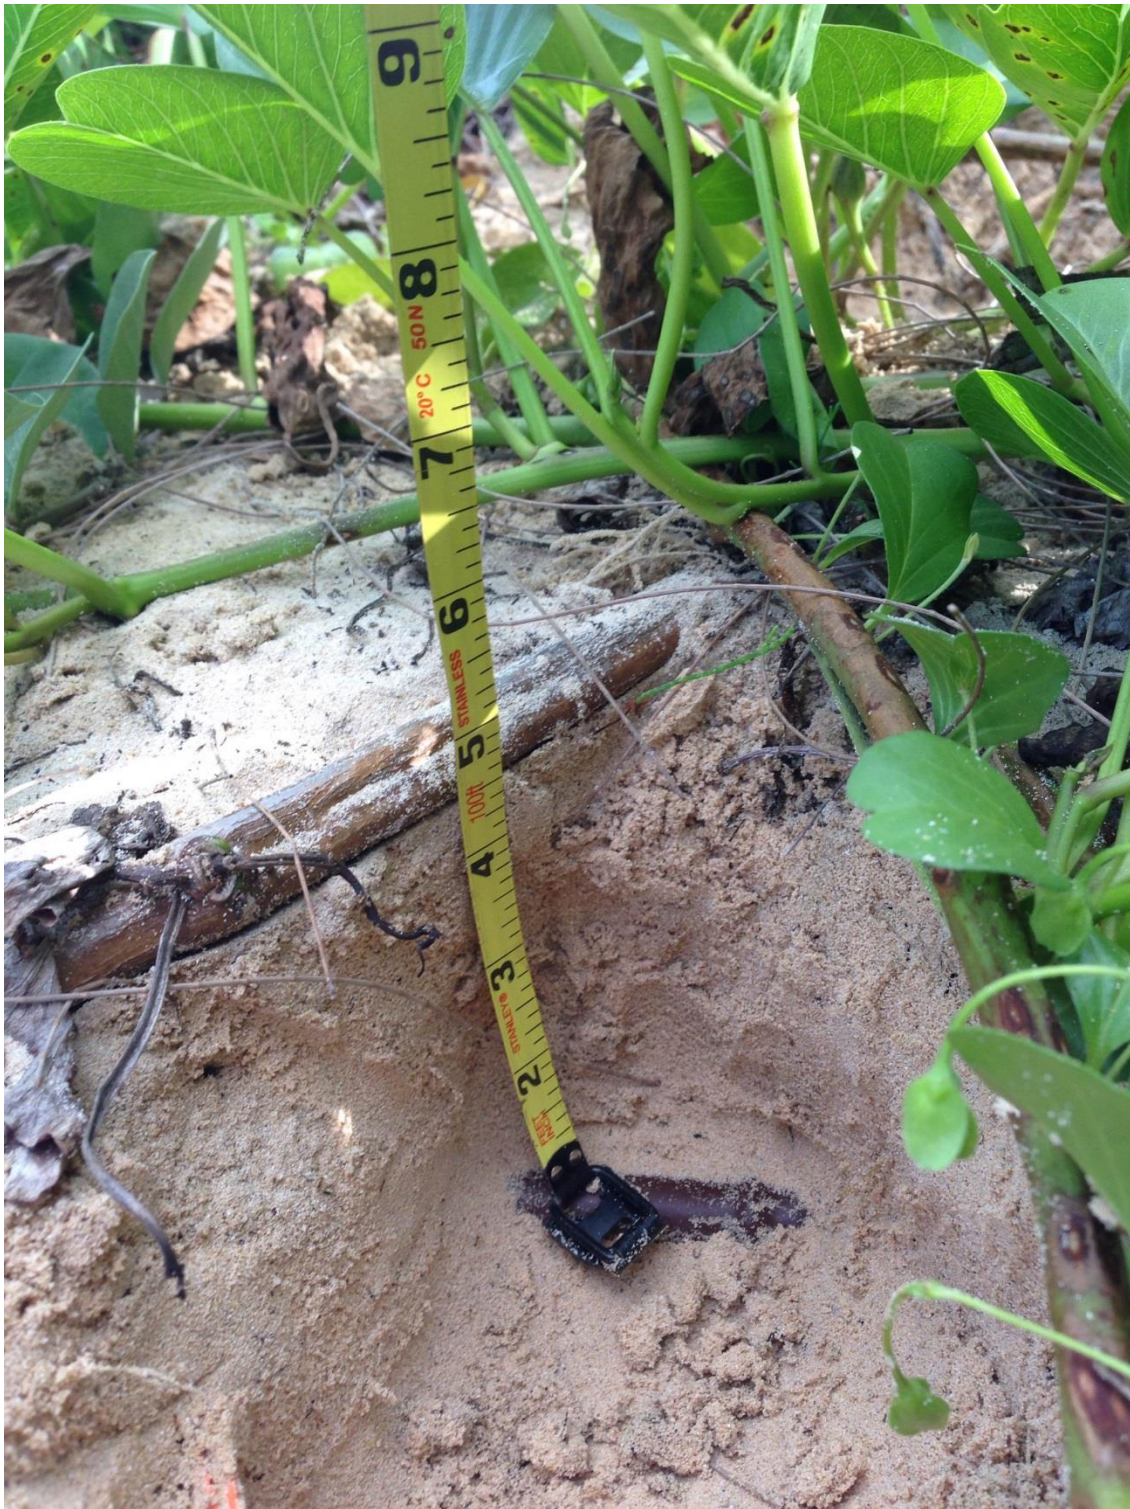
Figure 205. Dripline on the mountain side of the plot, facing north east (windward), 12 months after planting, buried 5". The sand accreted naturally, probably as a result of wind action.

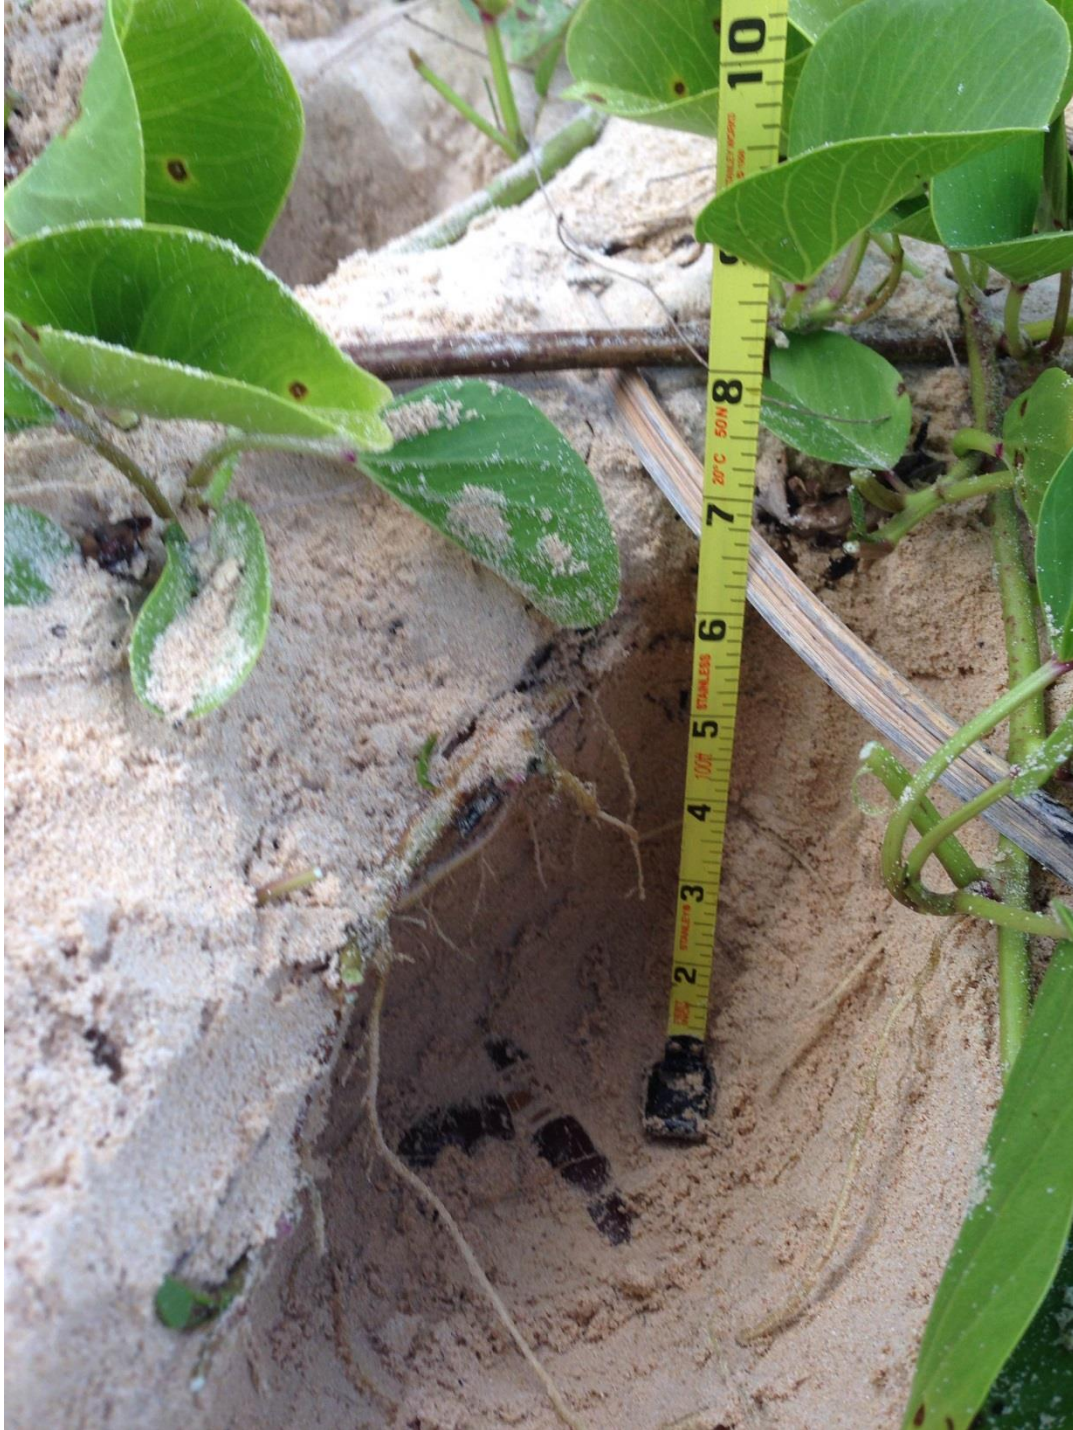
Figure 206. Dripline on the ocean side of the plot, facing north east (windward), 12 months after planting, buried 6 3/4". The sand accreted naturally, probably as a result of wind action.
